Description: Sirenusa Condo Complex, St. John, USVI "J" unit is last unit, lower right, behind dark brown area.

Description: "J" units at Sirenusa, St. John. Unit where pesticide was applied is lower, unit where residents were overcome is above.

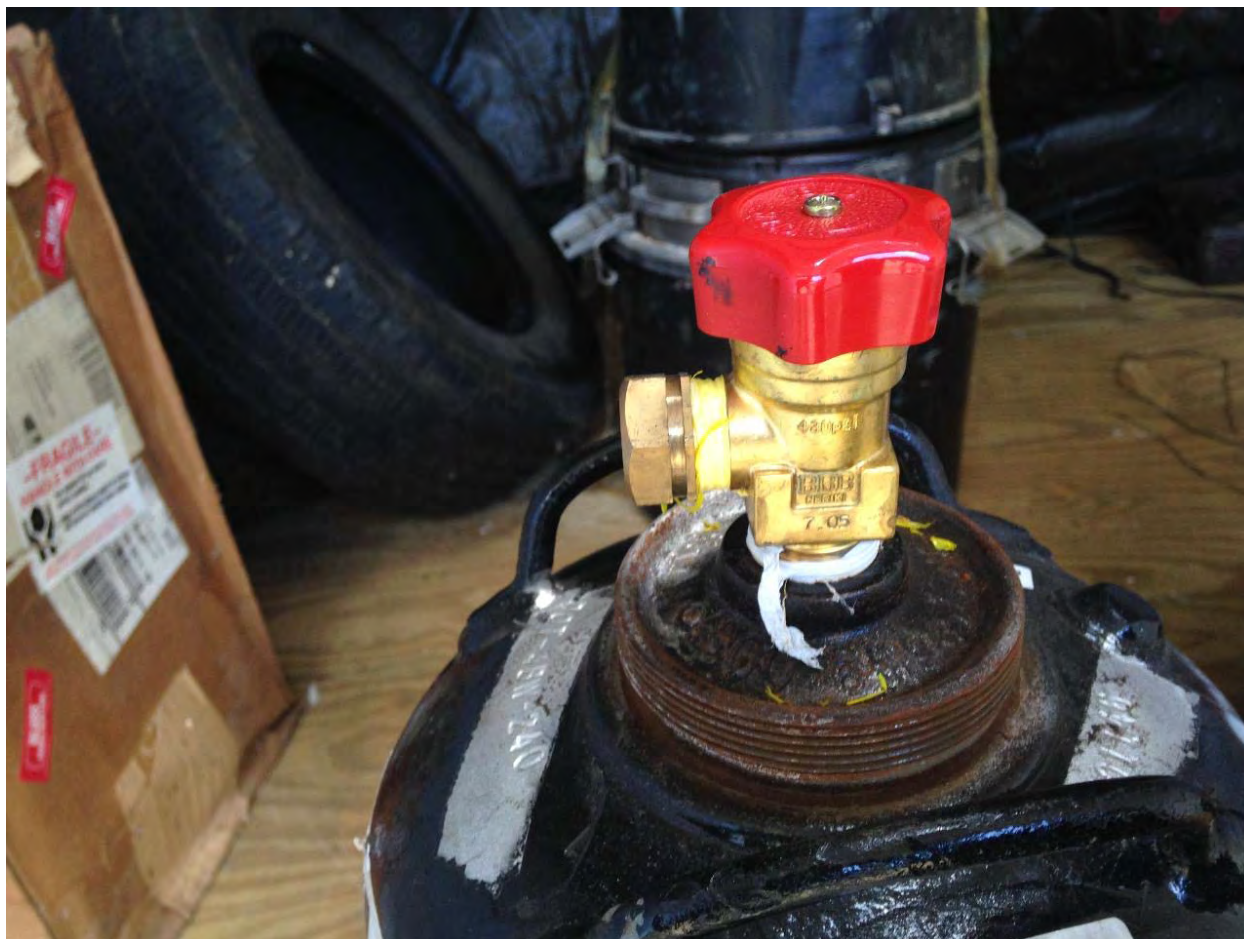
Description: Valve on Great Lakes MB cylinder on St. Thomas.

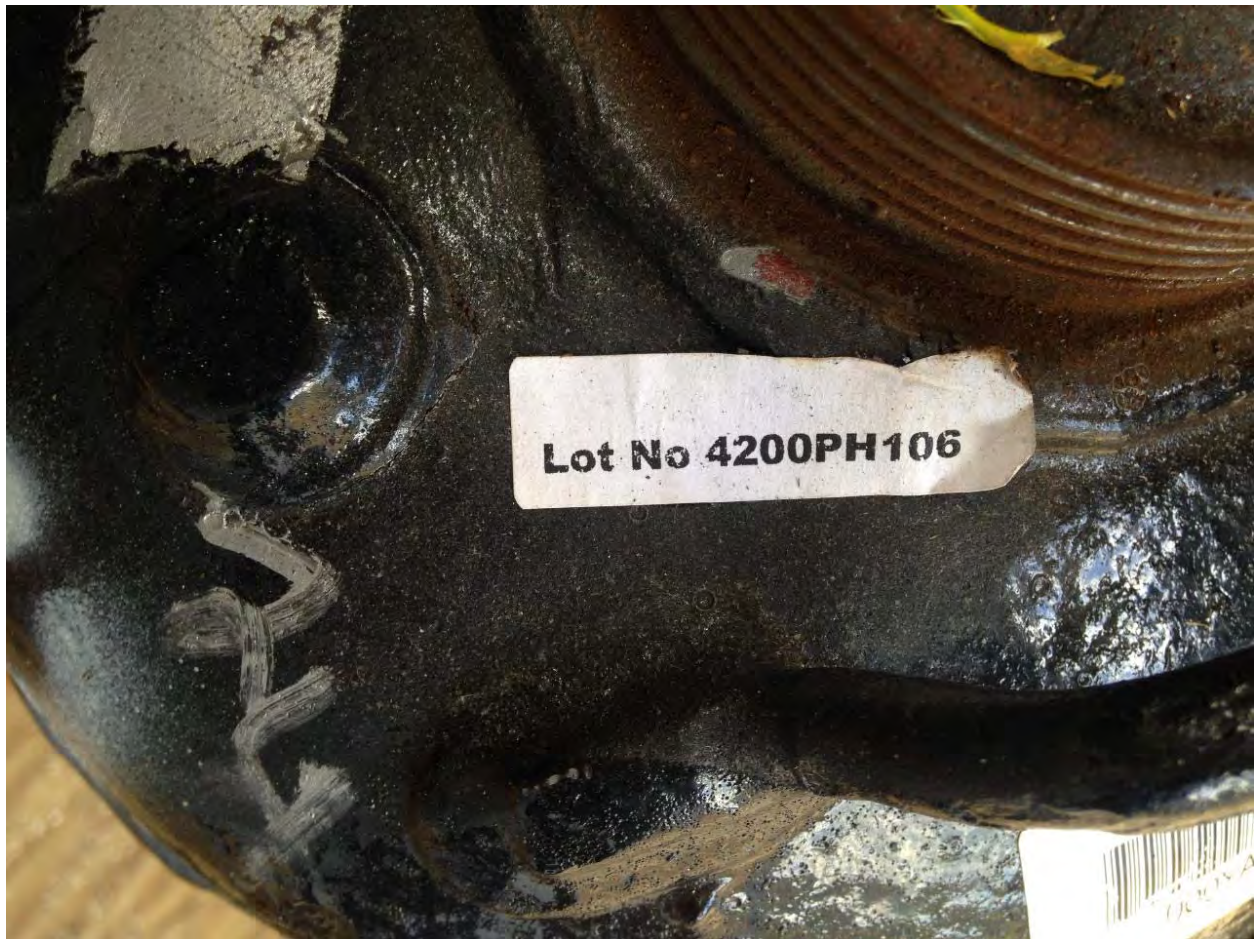
Description: Lot # on MB cylinder on St. Thomas
Date Taken: 4/7/2015
Security Level: Private
Category: Site Photo
Latitude: 18.3326194444444
Longitude: -64.9610833333333
Tags:

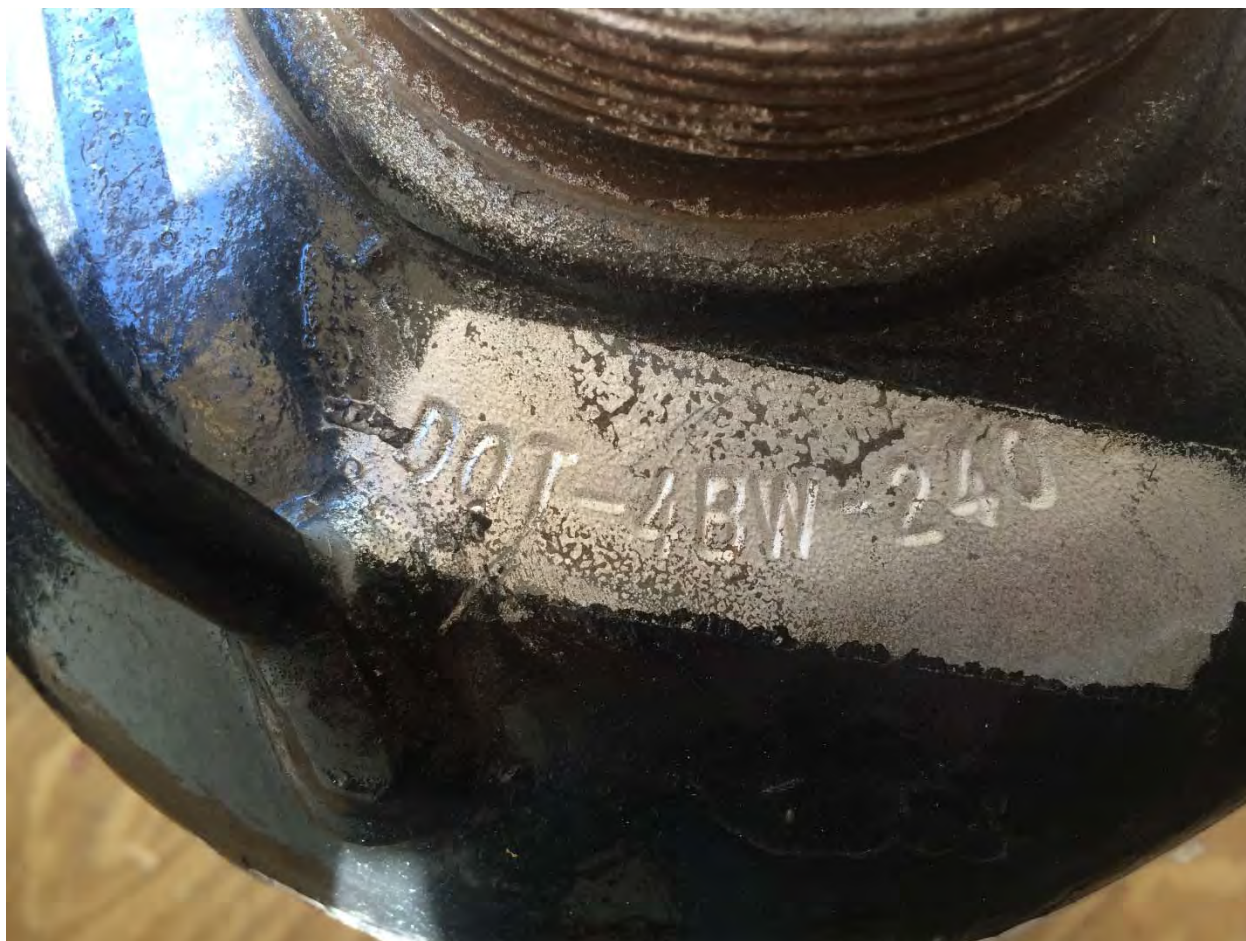
Description: DOT marking on MB cylinder on St. Thomas.

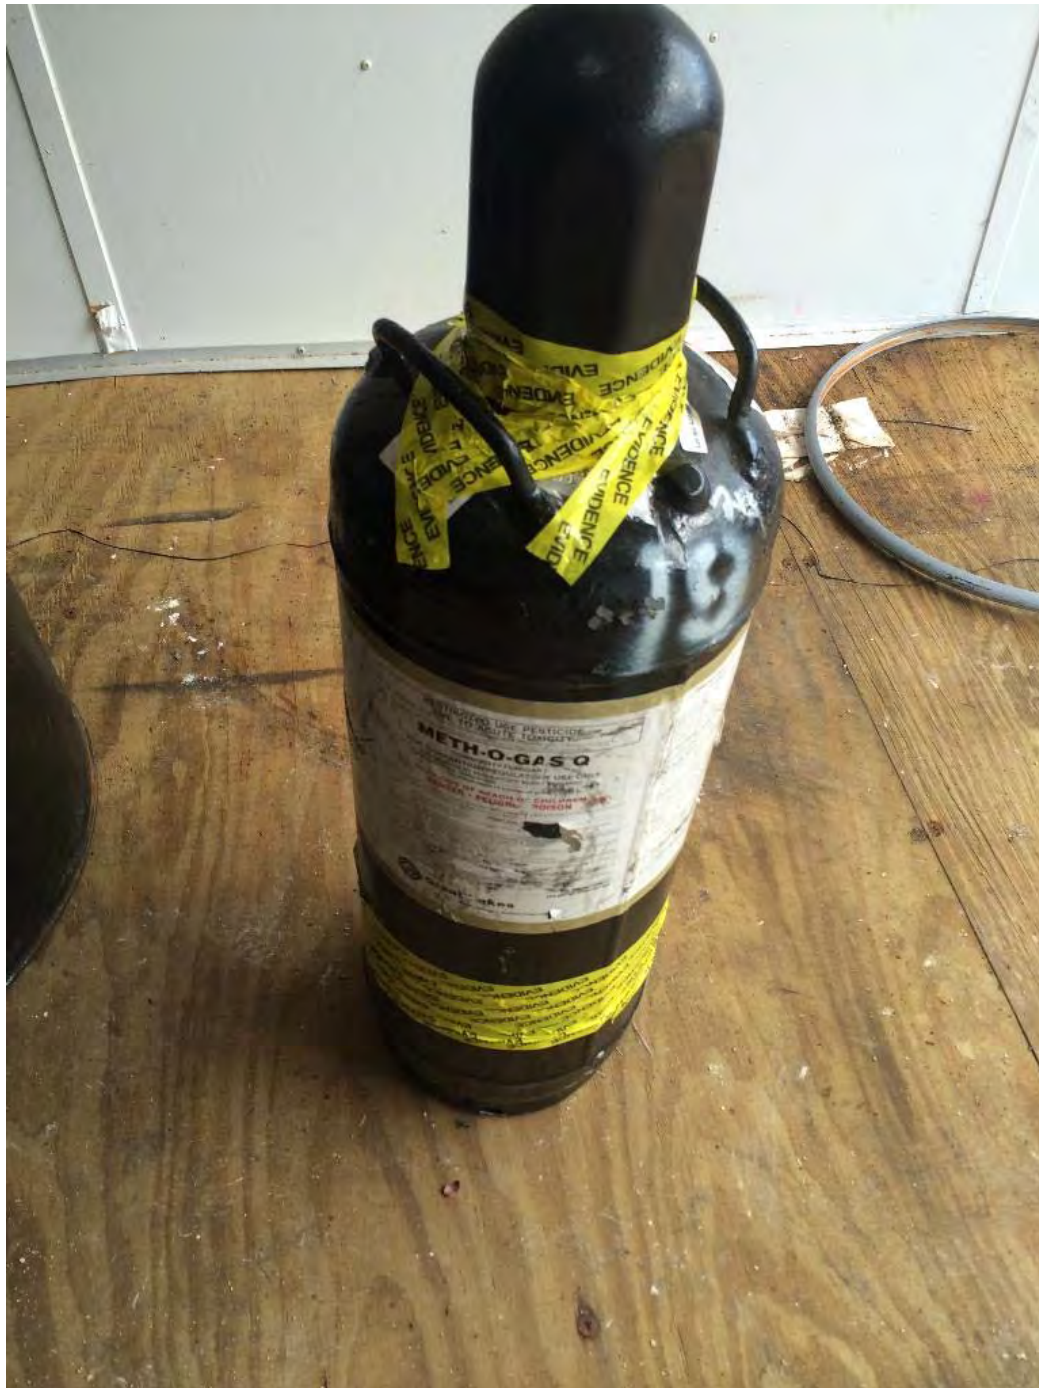
Description: MB cylinder on St. Thomas with evidence tape affixed.

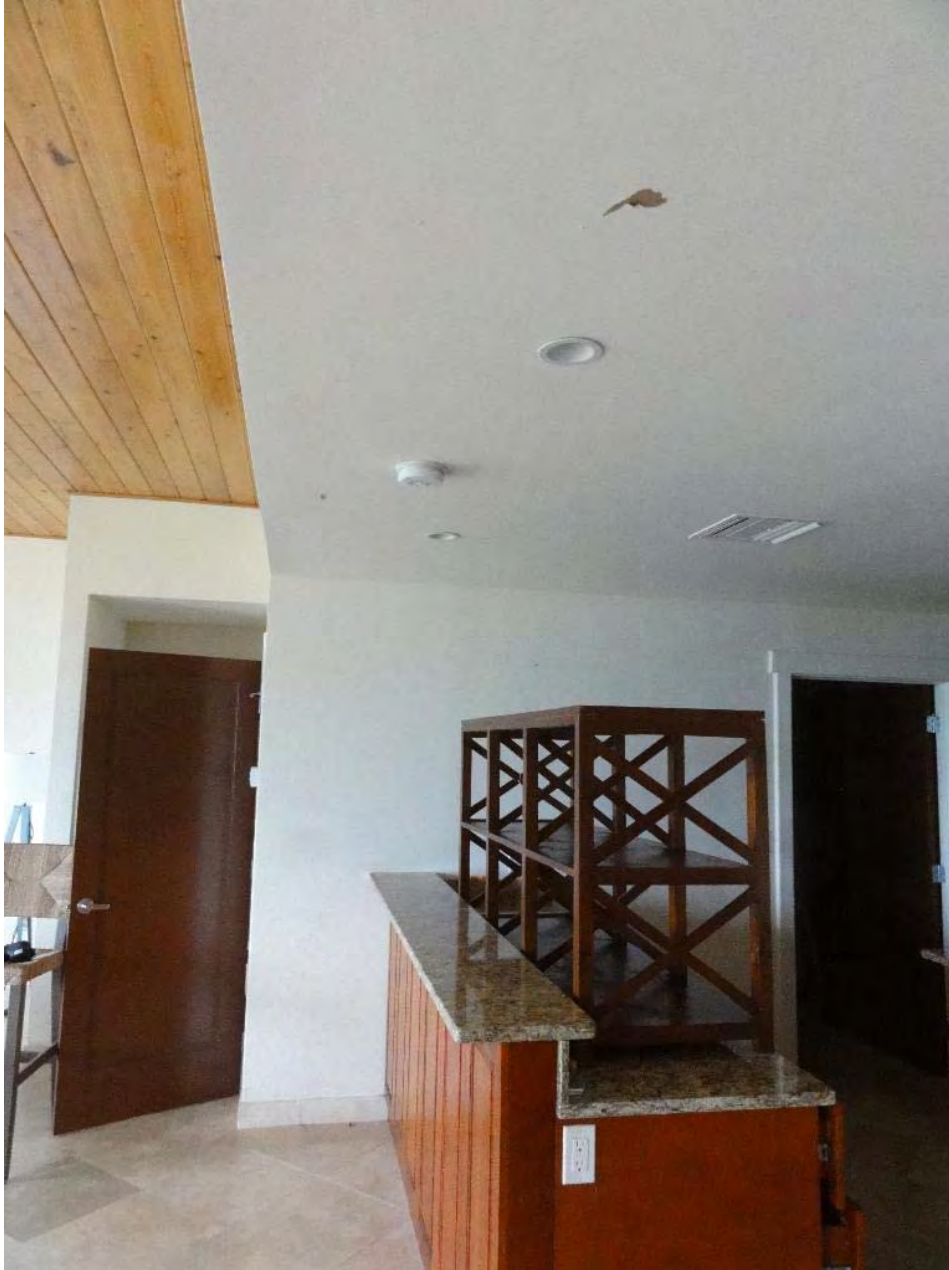
Description: View of Unit J lower ceiling where tape had been applied to seal the kitchen area off with plastic.

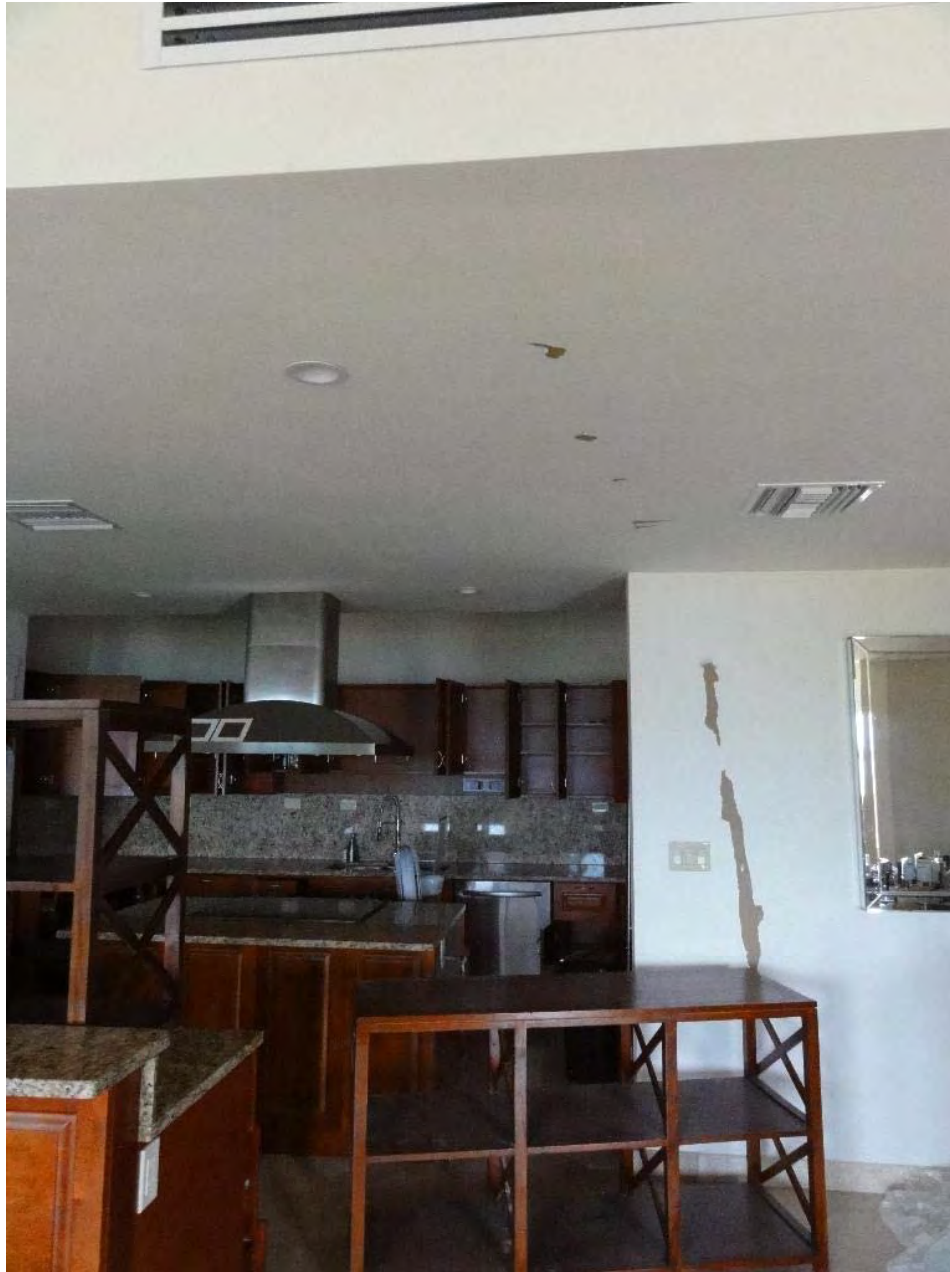
Description: View of kitchen area in Unit J lower. View of where tape was applied to seal the kitchen with plastic.

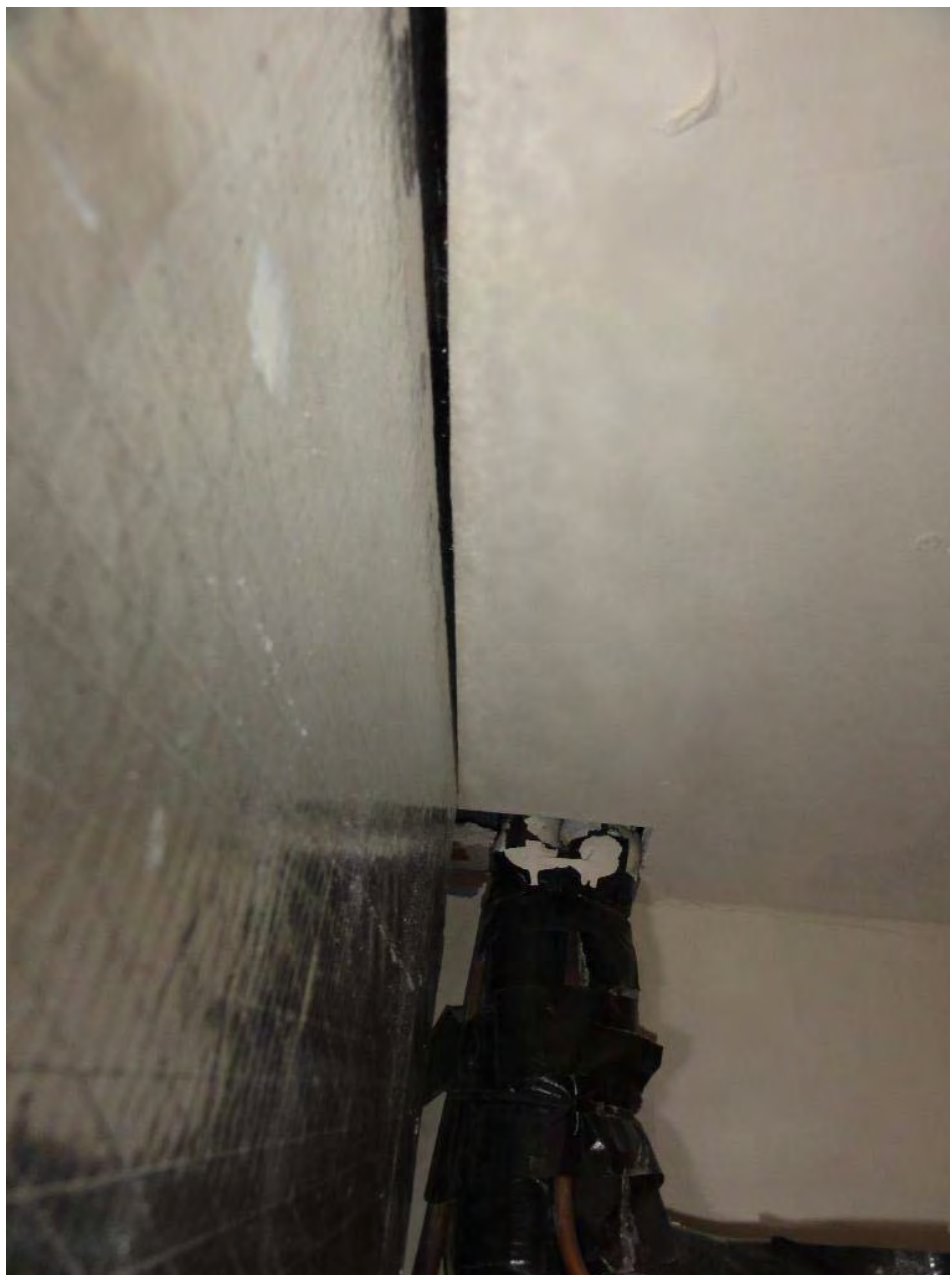
Description: View of large space between ceiling and right side of cooling unit in Unit J lower.

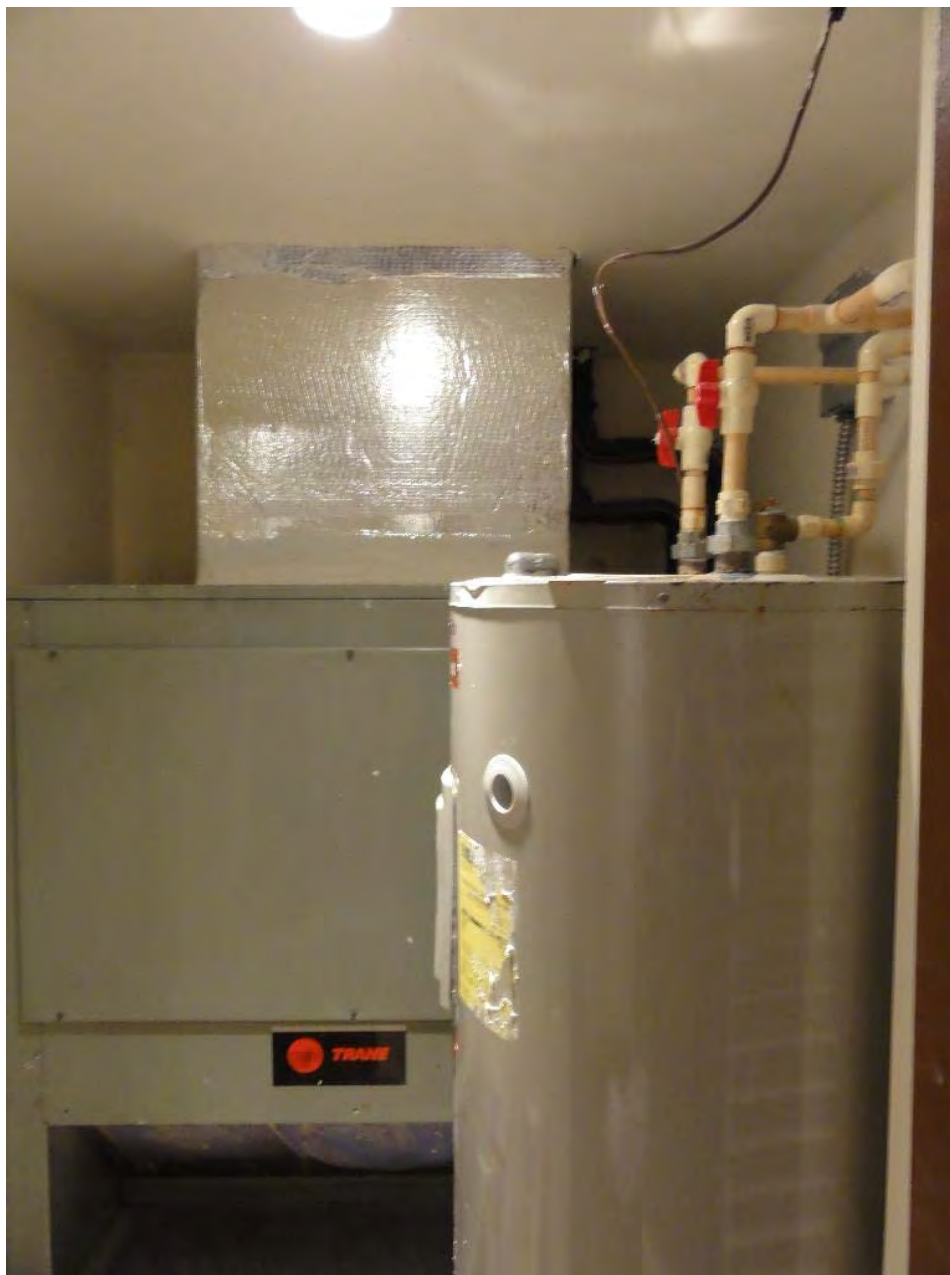
Description: View in pantry of Unit J lower of water heater and cooling system.

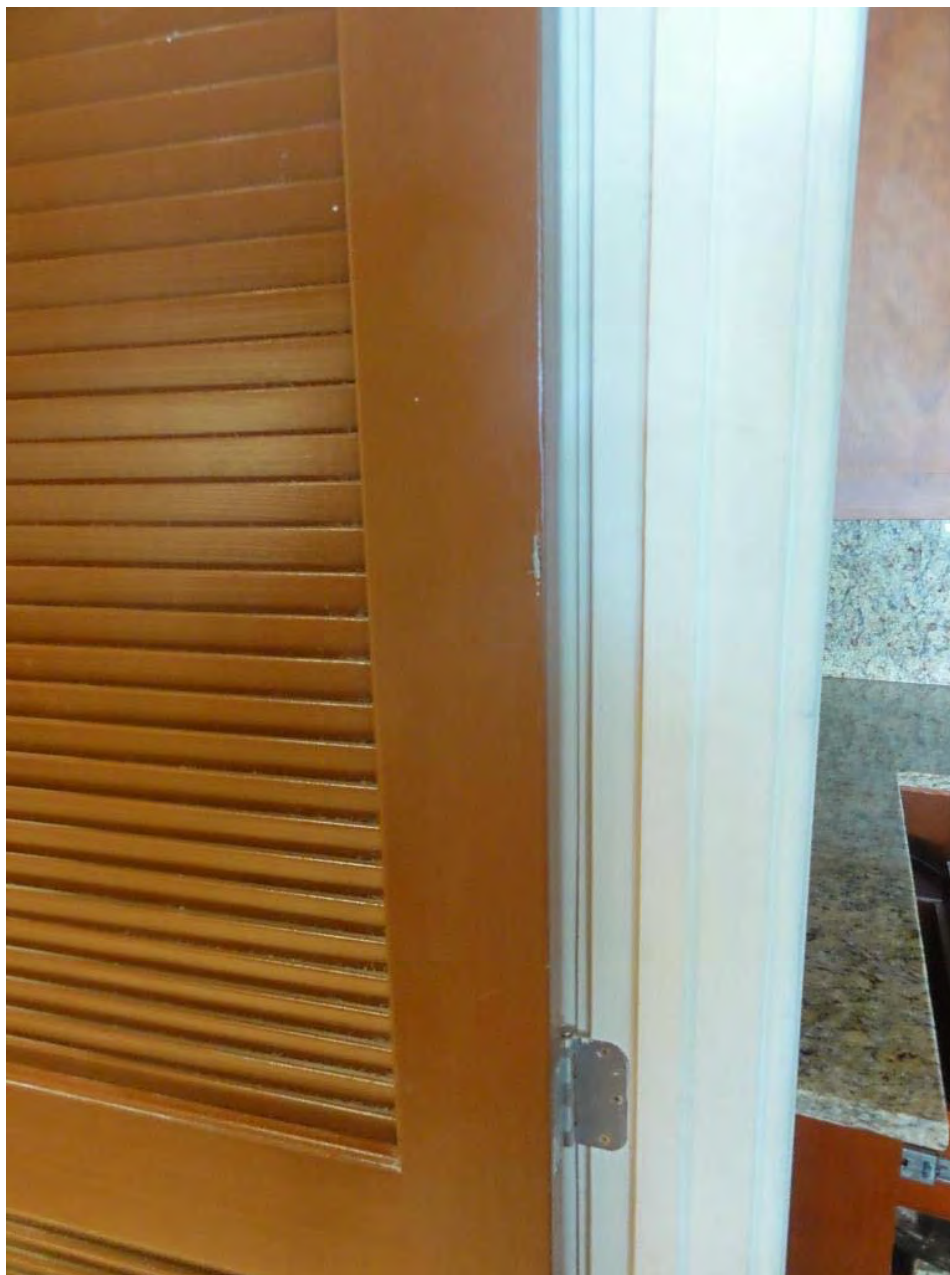
Description: Pantry door in Unit J lower. Residual duct tape appears on the edge of the door.

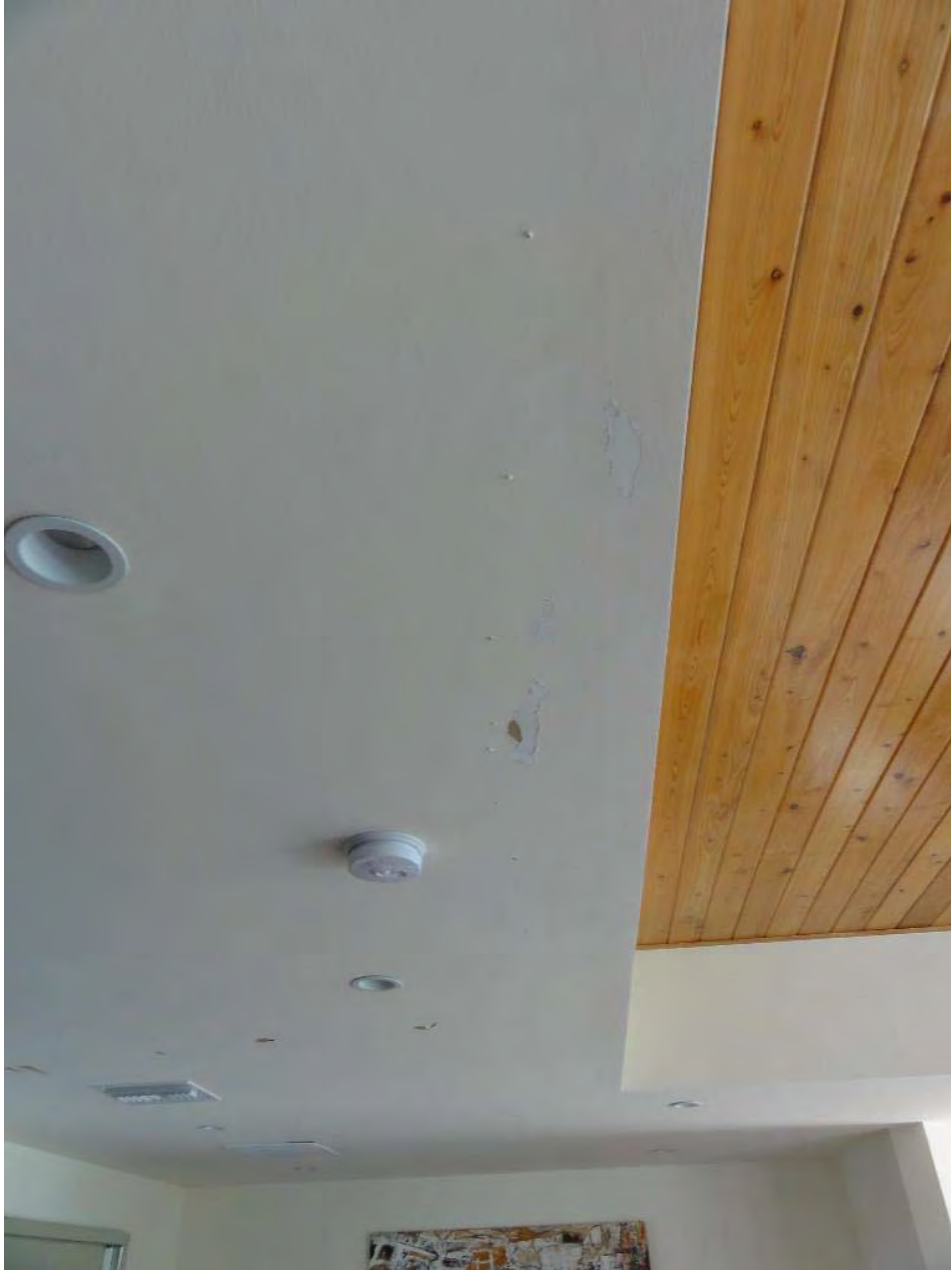
Description: Ceiling of Unit J lower where tape was applied to seal area off with plastic.

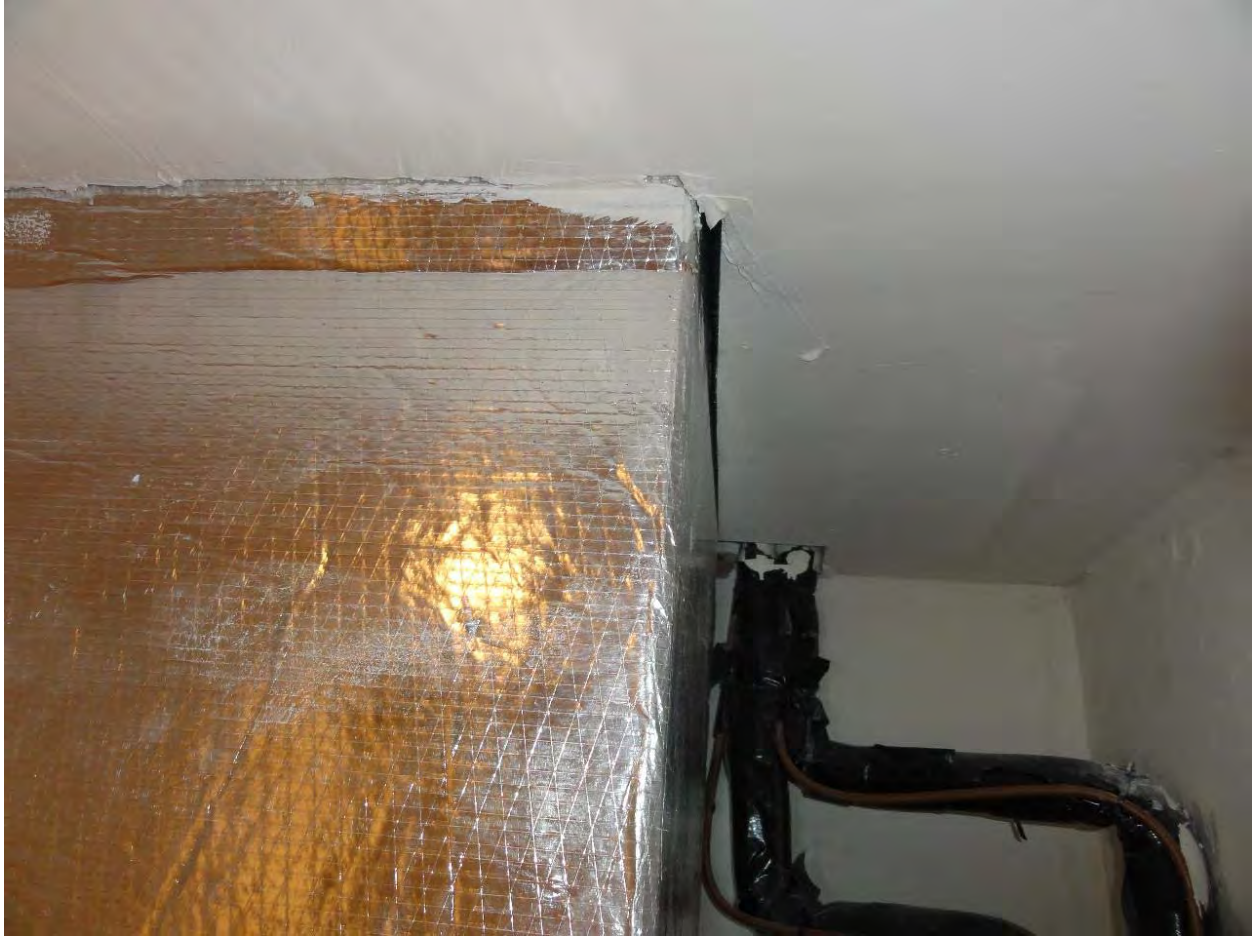
Description: View of large space between right side of cooling unit and ceiling in Unit J lower.

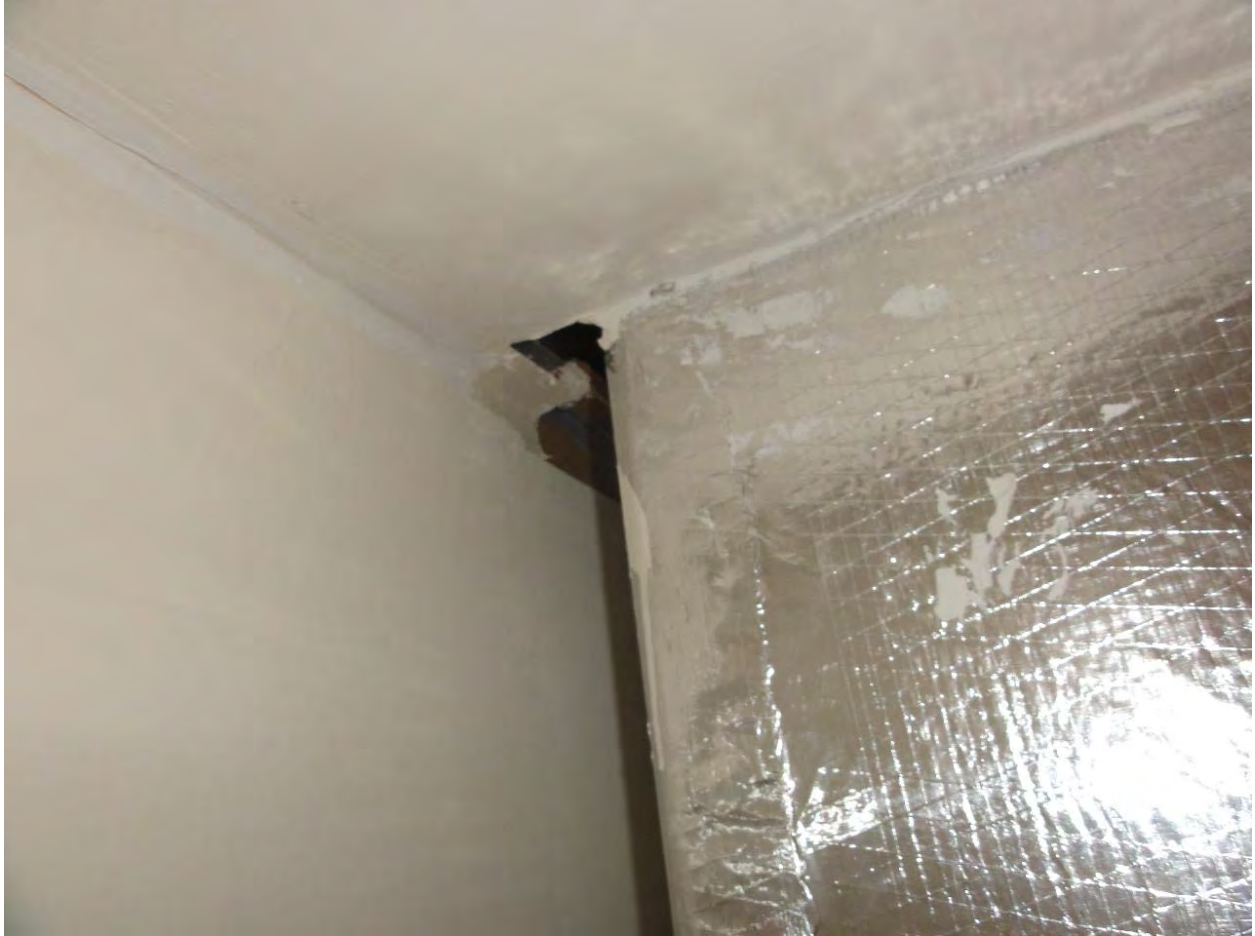
Description: View of large space between ceiling and rear of cooling unit in Unit J lower.

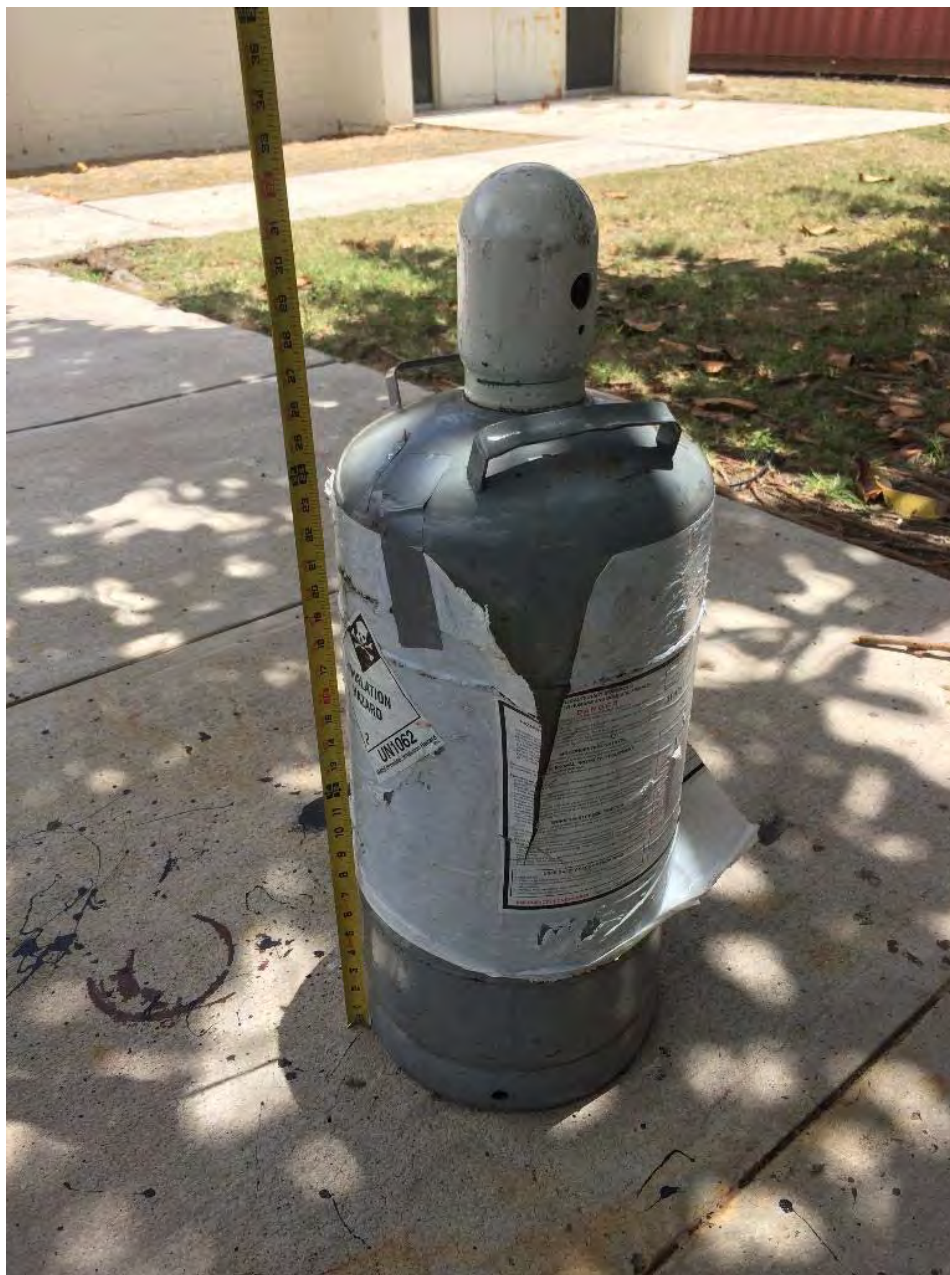
Description: Yard stick next to 100 lb. MB cylinder manufactured by Tri Est AG Group used by Terminix on St. Crix.

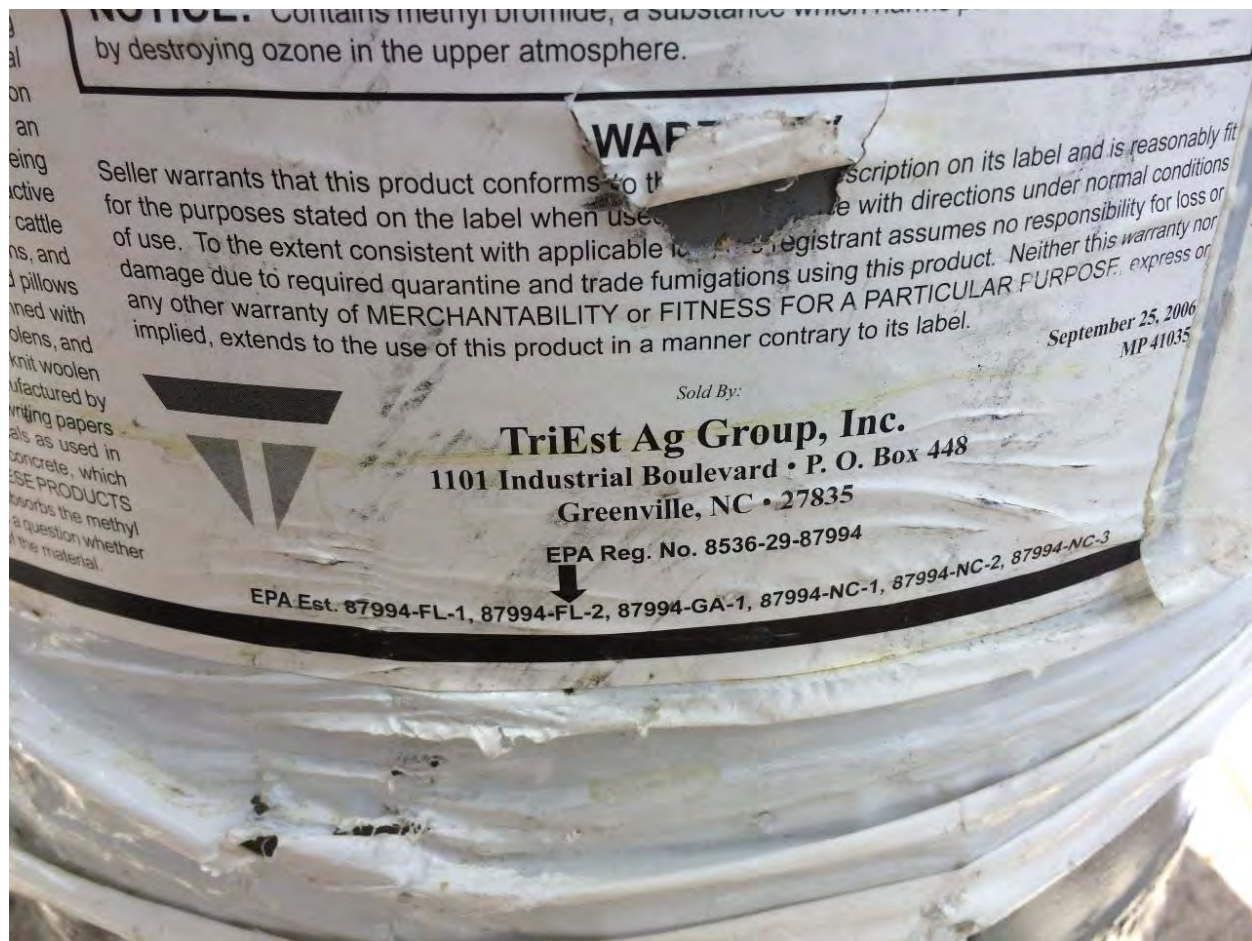
Description: EPA regis # and Est. # (just above heavy black line) on 100 lb. MB cylinder manufactured by Tri Est AG Group used by Terminix on St. Criox.

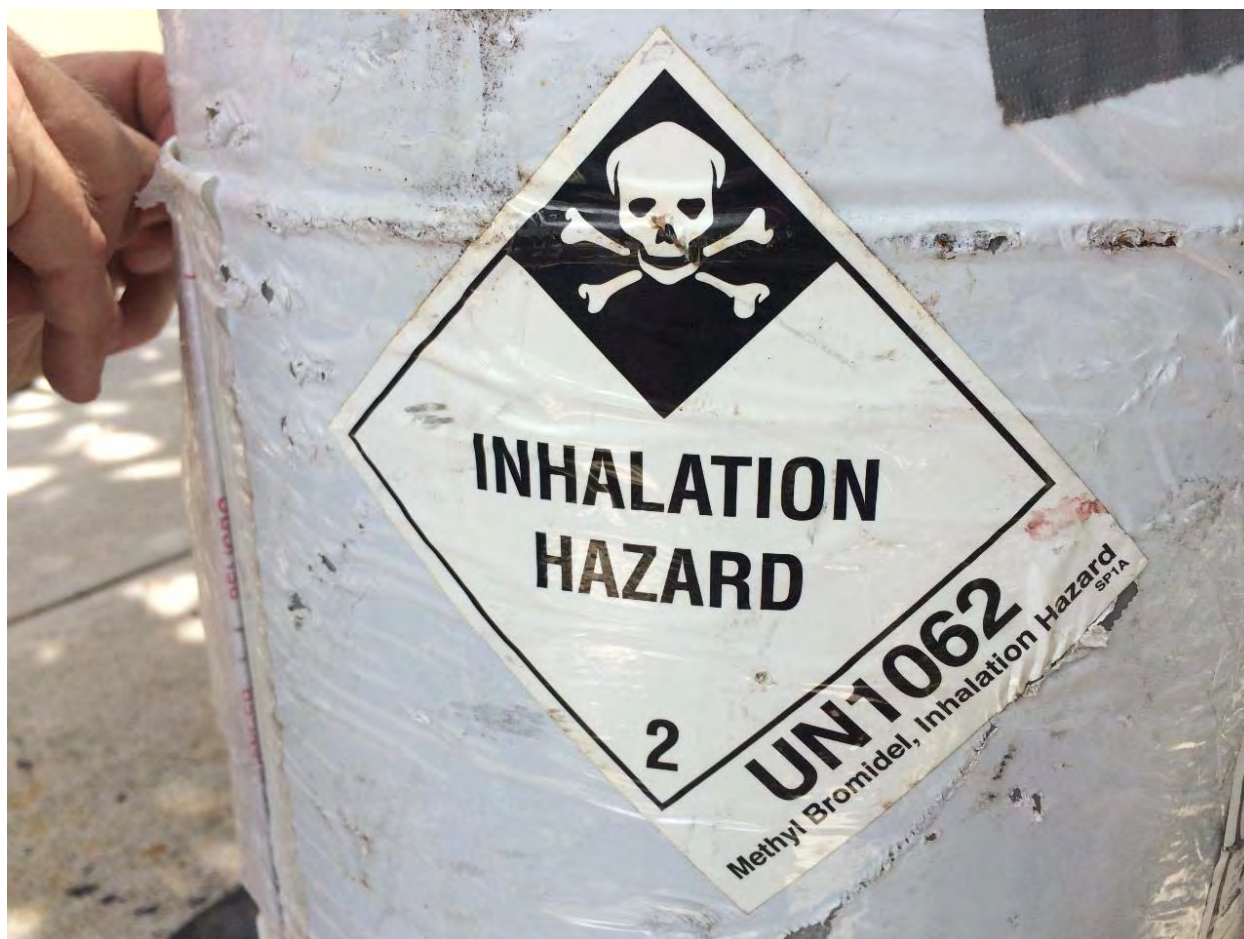
Description: Hazard label on 100 lb. MB cylinder manufactured by Tri Est AG Group used by Terminix on St. Croix

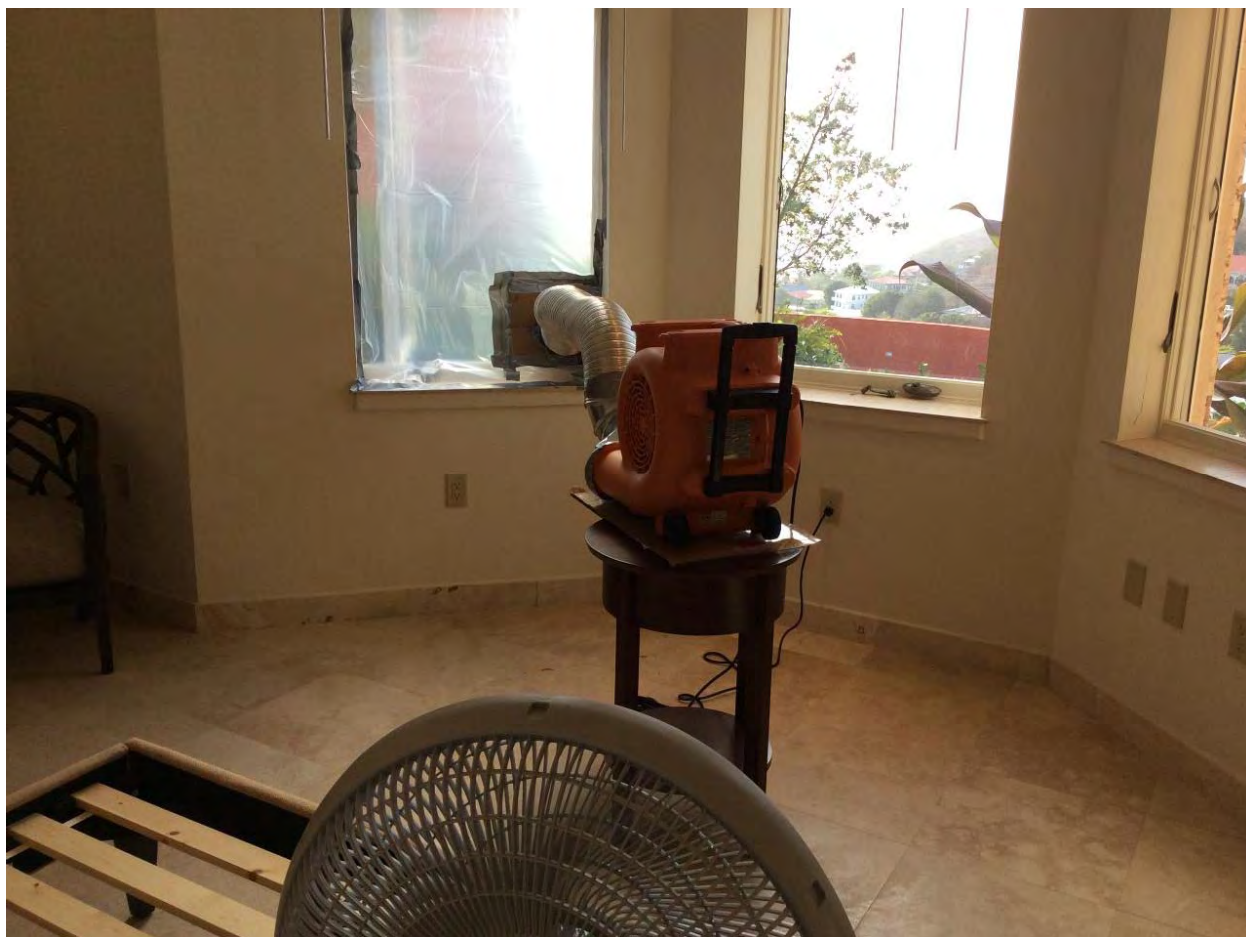
Description: Fans used to ventilate J unit.

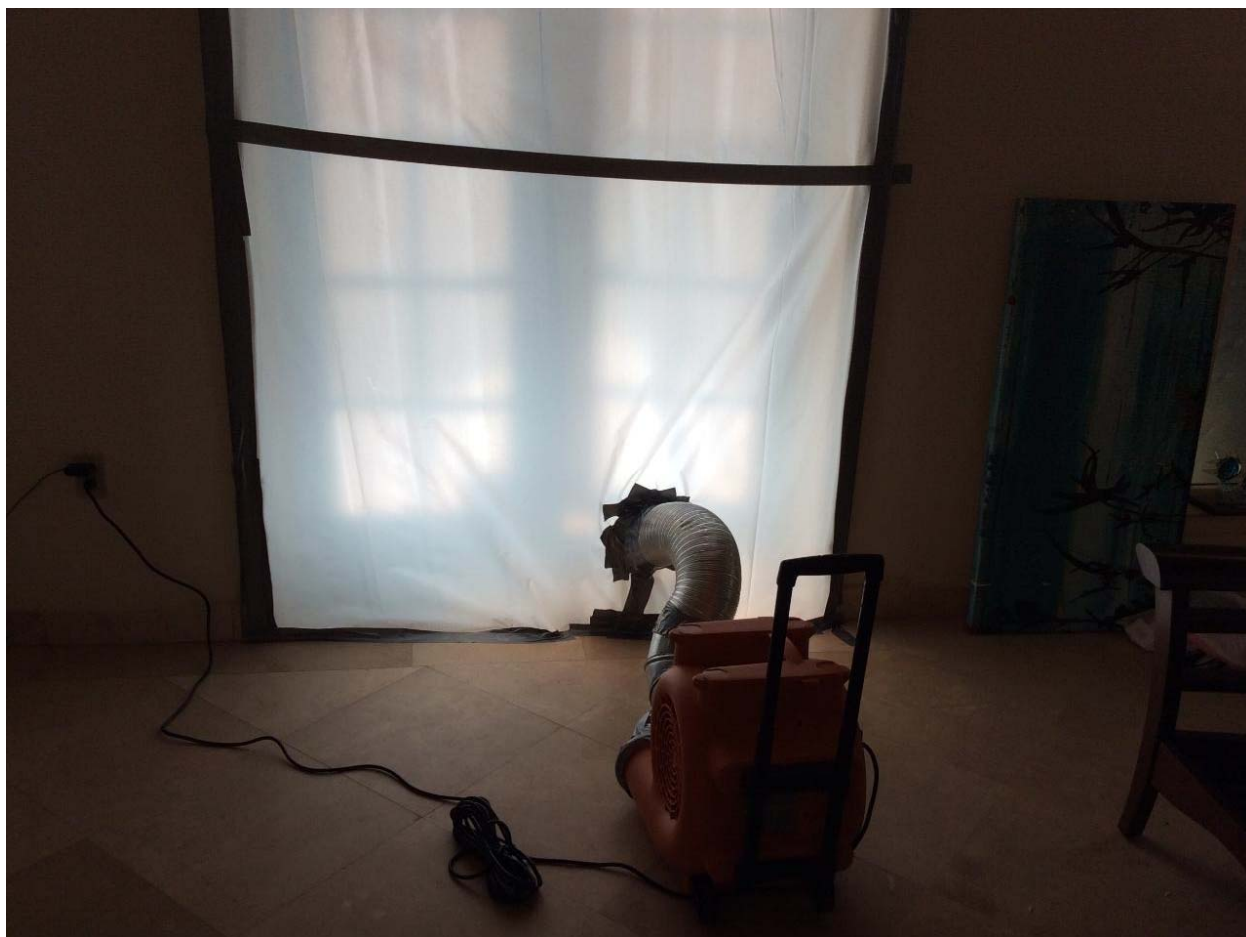
Description: Fan used to bring in outside air.

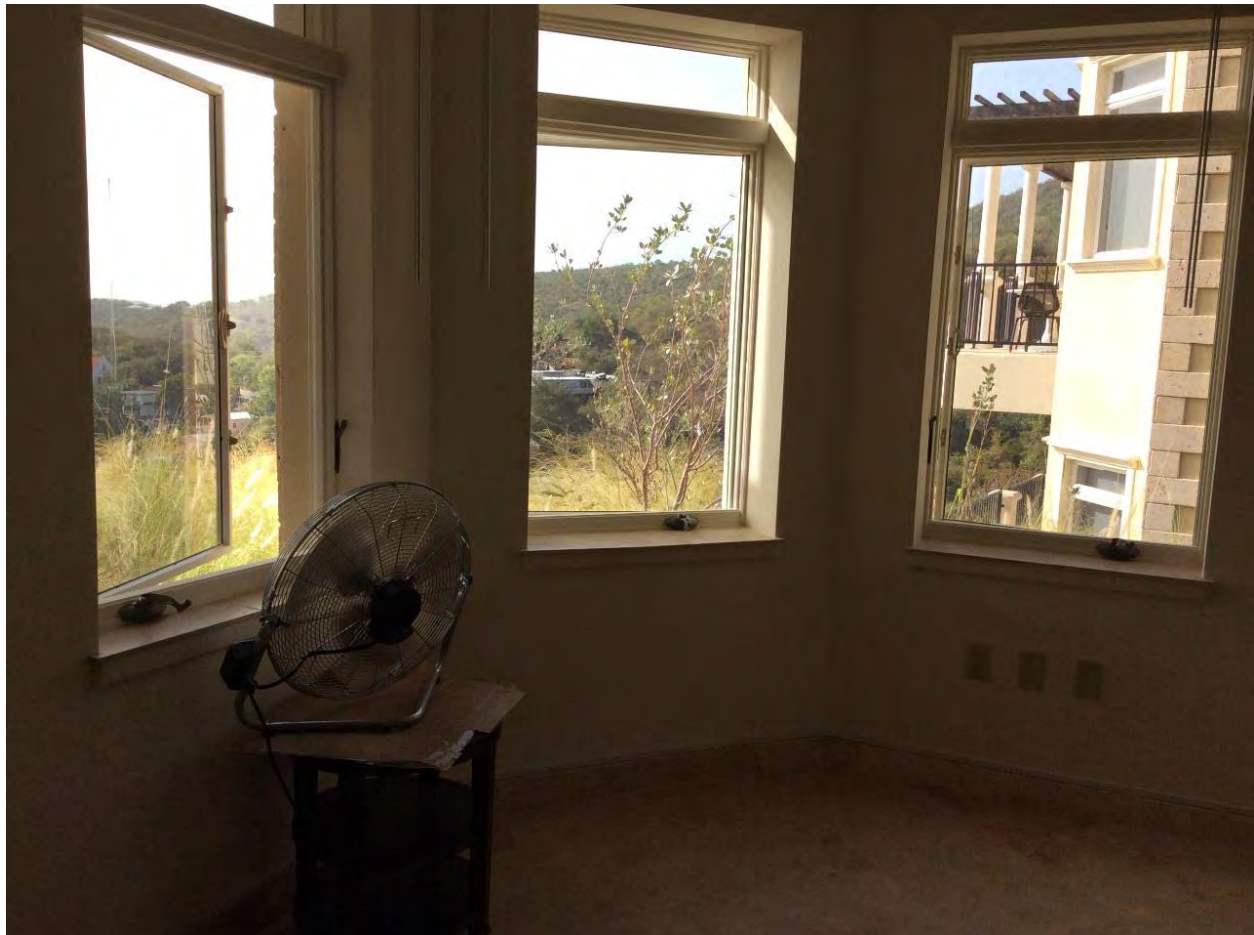
Description: Ventilation in progress in J unit.
